Screw catch can to fixing bracket and 'dry fit' to ascertain and mark fitting position with engine cover in place

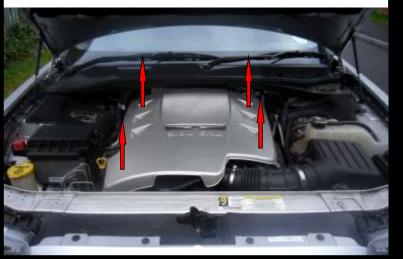
Step 3

Locate previously marked points and drill pilot holes, followed by 2 x 6mm bracket fixing holes

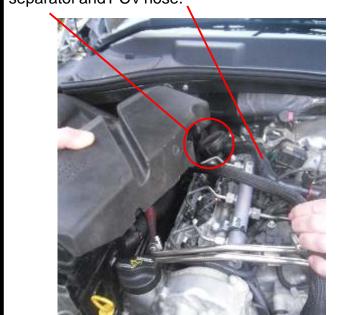
Remove left side black rubber insulation to expose oil separator and PCV hose.

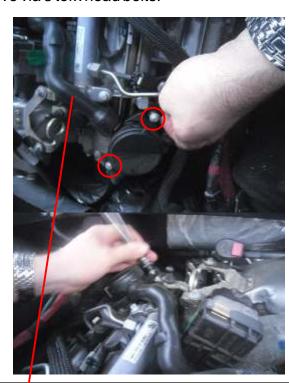
Locate oil separator to the rear of the bulkhead and remove via 3 torx head bolts.

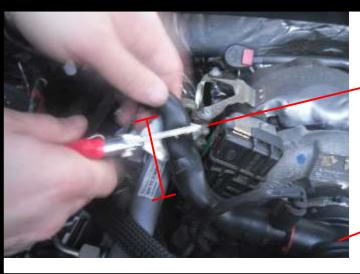
Step 8

Remove PCV hose from oil separator.

Trace hose to turbo air inlet pipe and cut the pipe at the point of the S shape nearest the turbo inlet pipe, leaving around two thirds of the S on the side of the turbo inlet hose.

Retain pipe off cut for following step (13) & dispose of old oil separator.

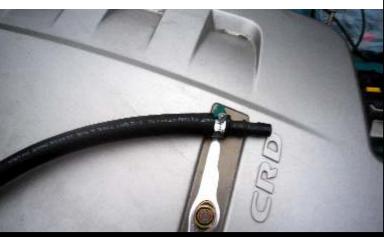
Push fit coupler to one of the pipes provided with fitting kit and secure with jubilee clip

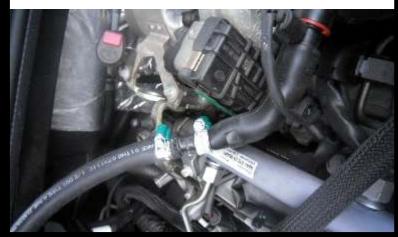
Step 10

Thread over 2nd jubilee onto previously cut PCV hose, push fit hose and secure with jubilee clip

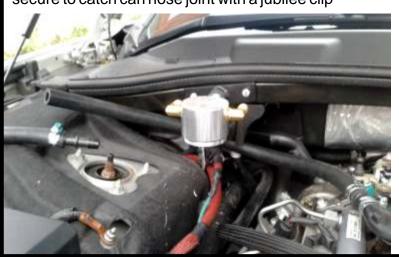
Step 11

Find route for hose to catch can right hand hose joint ensuring there are no tight bends or kinks, cut hose and secure to catch can hose joint with a jubilee clip

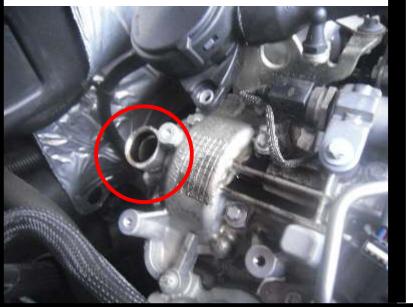
Step 12

Thoroughly clean PCV outlet exposed after removal of oil separator

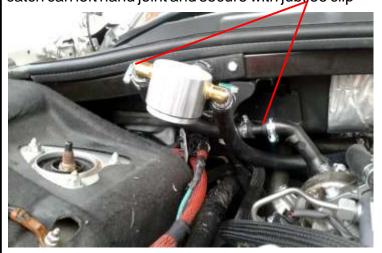
Repeating the previous procedure, push fit hose joint to one end of the 2nd fitting kit hose and secure with jubilee clip. Push fit new hose onto hose connected to PCV outlet, secure with jubilee clip and again as before, route hose to left catch can joint ensuring no tight bends or kinks. Cut as appropriate, push onto catch can left hand joint and secure with jubilee clip

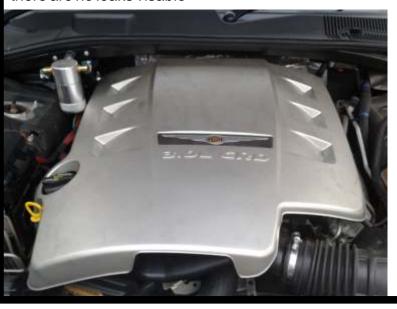
Step 15

Screw on catch can base to catch can head and refit black rubber insulation, ensuring pipes and hoses are routed correctly

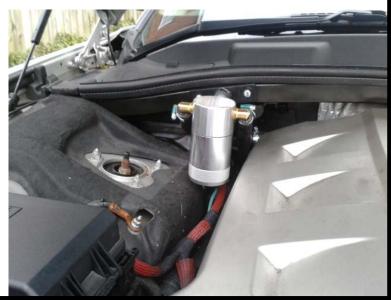
Step 16

Replace engine cover and job done. After the first few miles of fitting, check joints to ensure their security and there are no leaks visable
